PROCEEDINGS

10TH AUSTRALASIAN MASONRY CONFERENCE

Masonry Today and Tomorrow

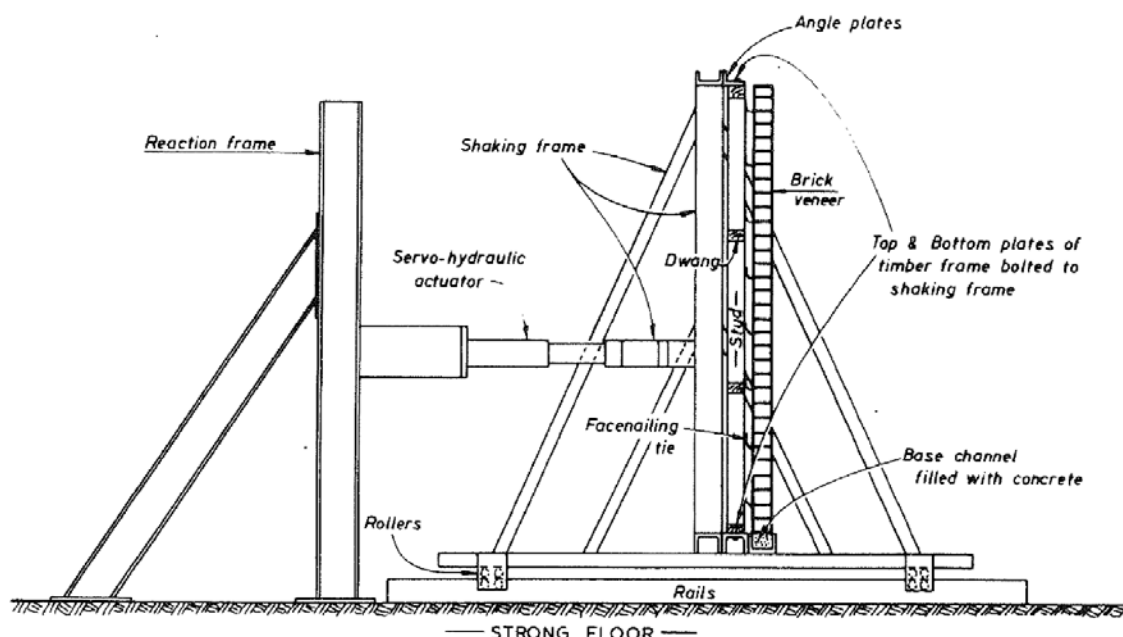
Figure 3: Test set-up for out-of-plane dynamic loading of clay brick masonry veneer walls (Priestley et al. 1979)

reputation of unreinforced masonry veneers when subjected to earthquakes, with much of this reputation being attributed to the failure of brick masonry facades and walls during the 1931 Napier and the 1968 Inangahua earthquakes. Seven unreinforced and two reinforced clay brick masonry veneer walls tied to conventional timber-frame backings were subjected to out-of-plane sinusoidal accelerations in the appropriate frequency range imitating earthquake loading, see Figure 3, where the stud spacing, veneer-tie type and the initial distribution of pre-formed cracking were the main variables. Out-of-plane face loading was specifically considered because the draft Code of Practice for light timber frame construction required the entire in-plane load demands to be carried by the timber frame bracing to which the masonry veneer wall is fixed. From this testing, it was concluded that when unreinforced masonry veneers were built to the specifications prescribed in the draft Code of Practice, acceptable response could be expected for earthquake loading levels in excess of those expected for the highest seismic zone in New Zealand. Furthermore, it was found that pre-formed horizontal or diagonal panel cracking had little or no apparent influence on the ultimate performance of the veneers.

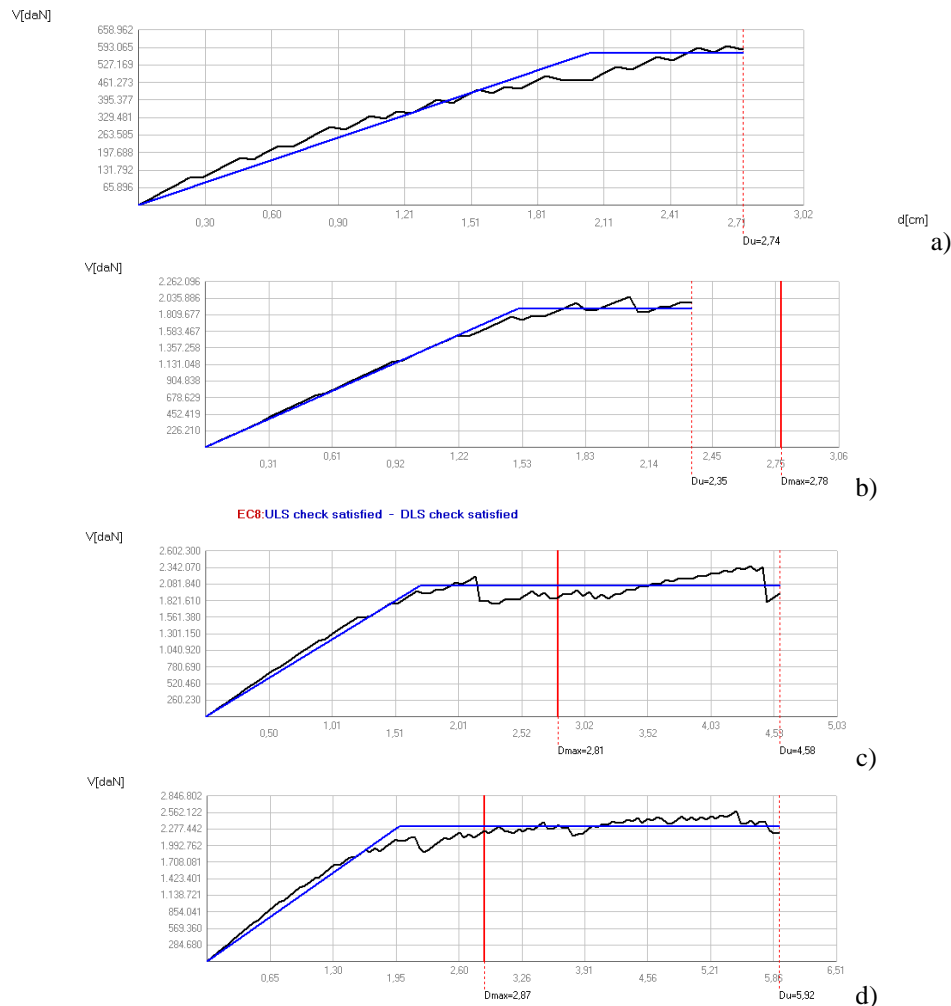
Figure 13: Pushover envelopes for X direction for 1st, 2nd, 3rd and 4th variant of analysis.

Though the increase of seismic resistivity for masonry building is mostly related to improved strength characteristics, comparison of pushover curves for different variants in the X direction reveals that for the higher masonry buildings the increase of ductility has important role (Figure 13).

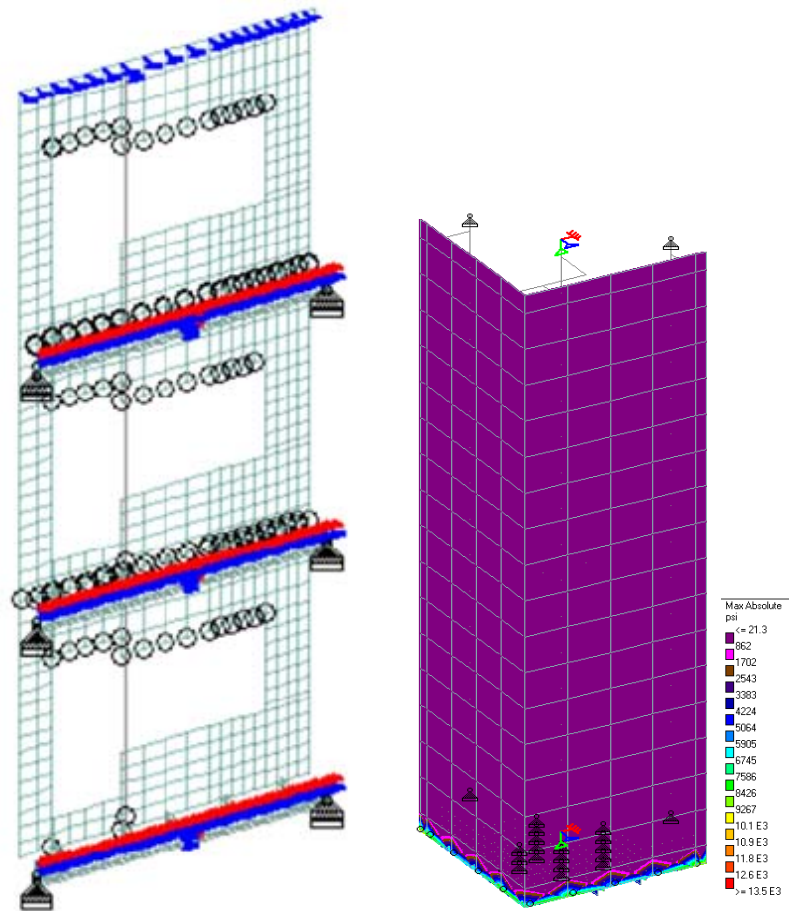
Figure 4: Typical Finite Element Models of Masonry Veneer Systems

Although not usual, more sophisticated finite element models of the veneer wall system can be developed and, if the deformation of the ties and systems and supports are properly modelled, can be used to accurately predict the behavior of the wall system. Figure 4 shows a typical model of a veneer wall system. The veneer can be modelled using plate elements, the ties modelled as axial elements and the backing wall modelled as beam elements or plates as conditions warrant. These models can also be extended to incorporate models of the spandrel beams as well.

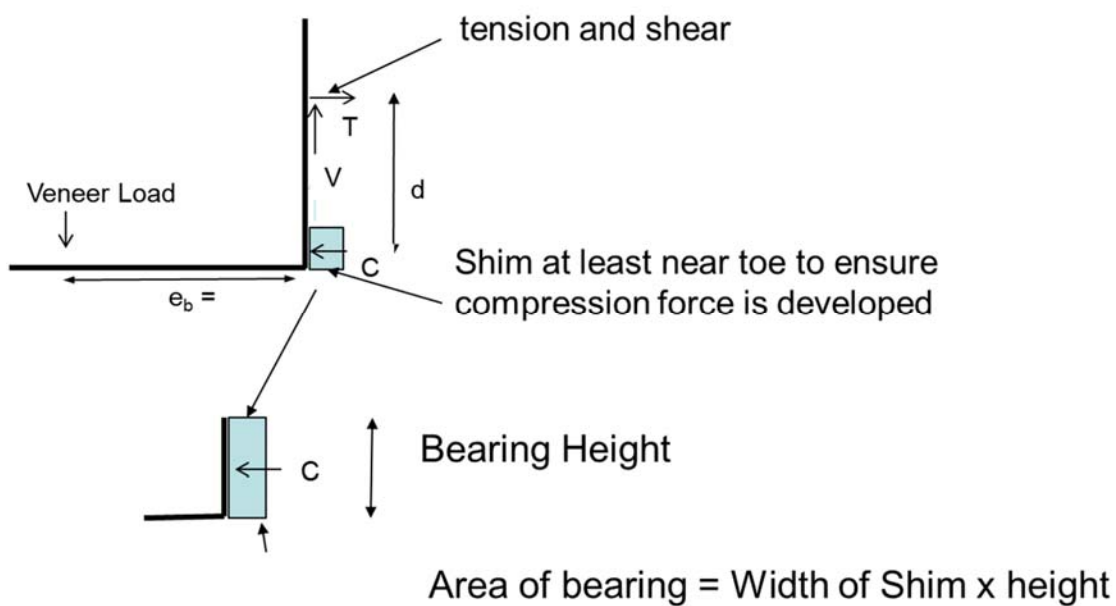
Figure 9: Assumed Bearing Conditions behind angle at Anchor Location

The final aspect of steel shelf angle anchor design that must be evaluated is the bearing of the steel angle near the toe. To ensure adequate capacity and to account for construction tolerances, the angle must be shimmed to ensure adequate bearing capacity directly below the anchor bolt. Figure 9 shows the assumed bearing conditions.

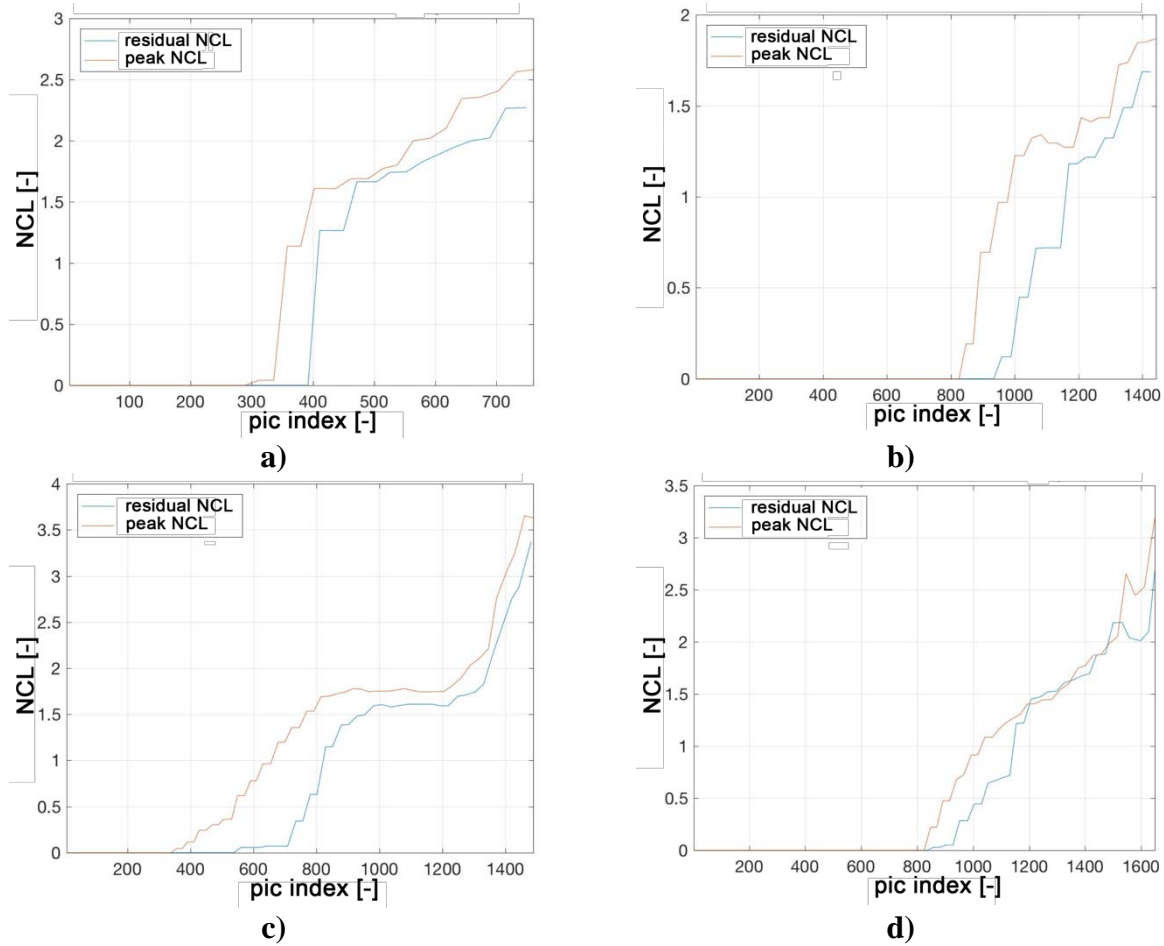
Figure 7: Residual and peak NCL for a) Wall001, b) Wall002, c) Wall003, and d) Wall004

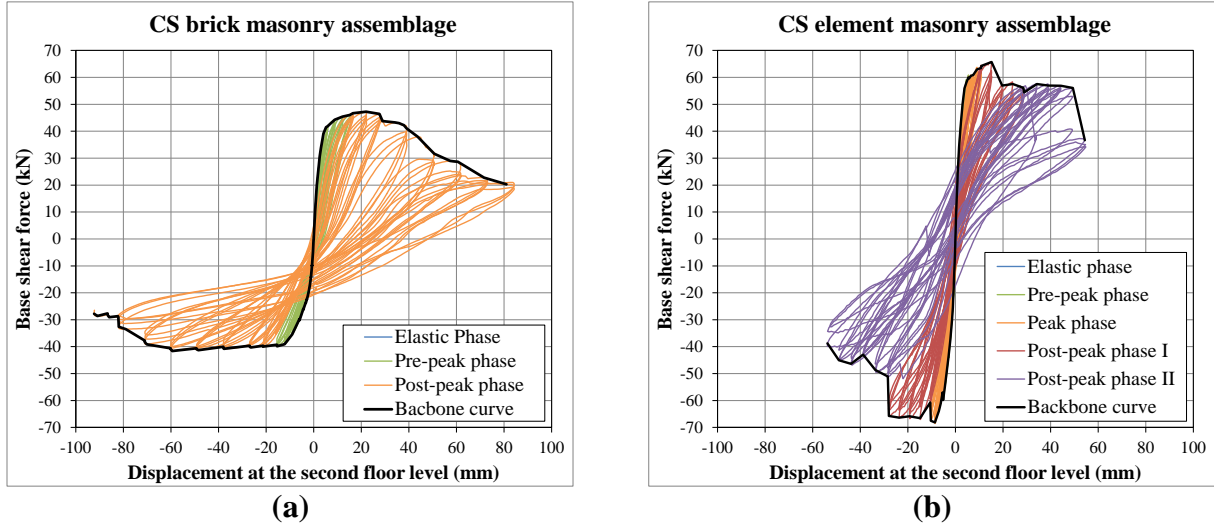
Figure 4: Capacity curve: (a) CS brick masonry; (b) CS element masonry.

CS brick masonry assemblage the 20% reduction in base shear force was obtained at a displacement of $d_2 = +43$ mm and $d_2 = -80$ mm, while for the CS element masonry assemblage it was reached at a displacement of $d_2 = -28$ mm and $d_2 = +50$ mm.

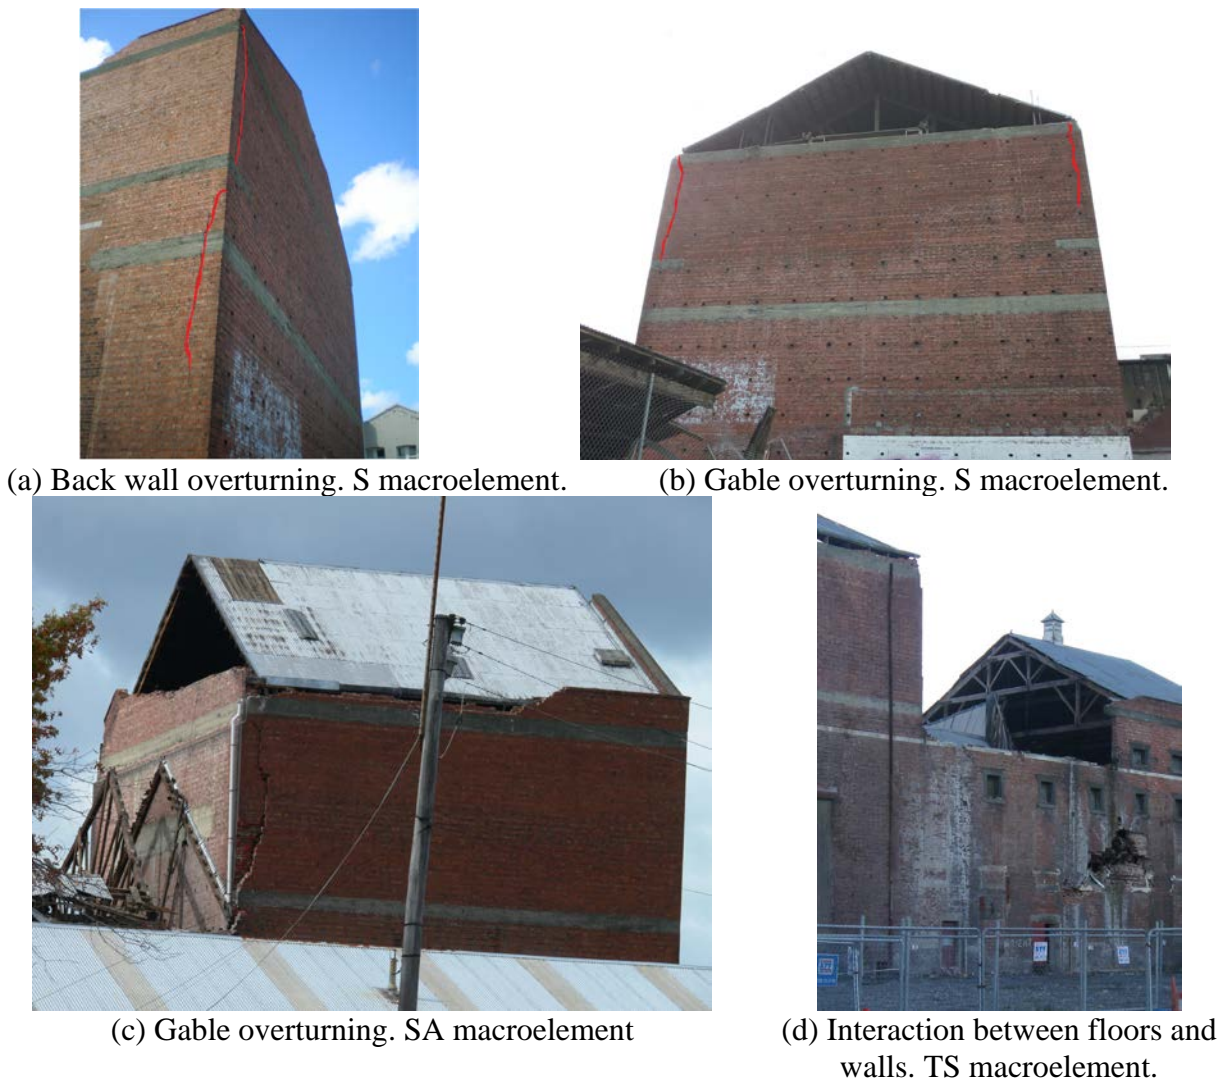
Figure 5: Odeon Theatre collapse mechanisms, Christchurch.

Evidence of macroelement formation regarding typology III buildings was identified in the 2010-2011 Canterbury earthquakes as shown in Figure 5. The use of bounding reinforced concrete elements combined with URM (Figure 5) reflects a nationwide trend in utilizing reinforcing elements after the destructive M_s 7.8 1931 Hawkes Bay earthquake (Walsh et al., 2014). Several examples of HURM buildings can be found across the New Zealand context (Russell & Ingham, 2010). Despite the combination of materials, the macroelements are still noticeable, portraying their strong autonomous behaviour. The limited stock of theatres in Christchurch only allowed the identification of some macroelements, with some assumptions about the remaining macroelements being necessary until the rest are confirmed. Figure 6 represents the proposed discretization into macroelements of typology III buildings.

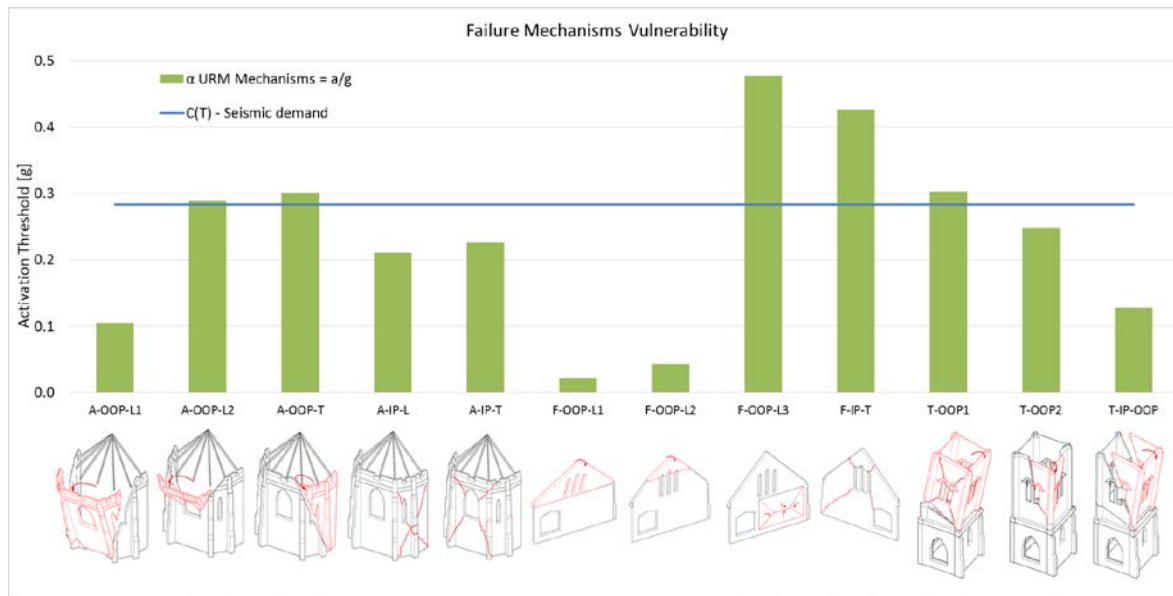
Figure 8: Activation threshold of the possible collapse mechanisms of three macroelements calculated and compared with the seismic demand.

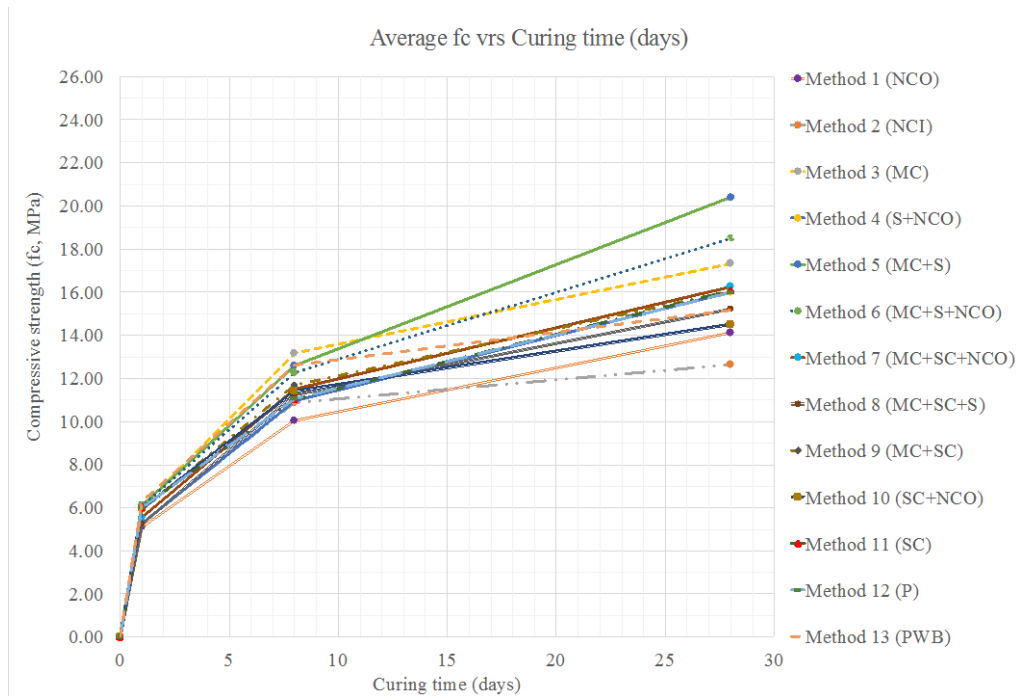
Figure 15: fc average of blocks exposed to different times and methods of cure

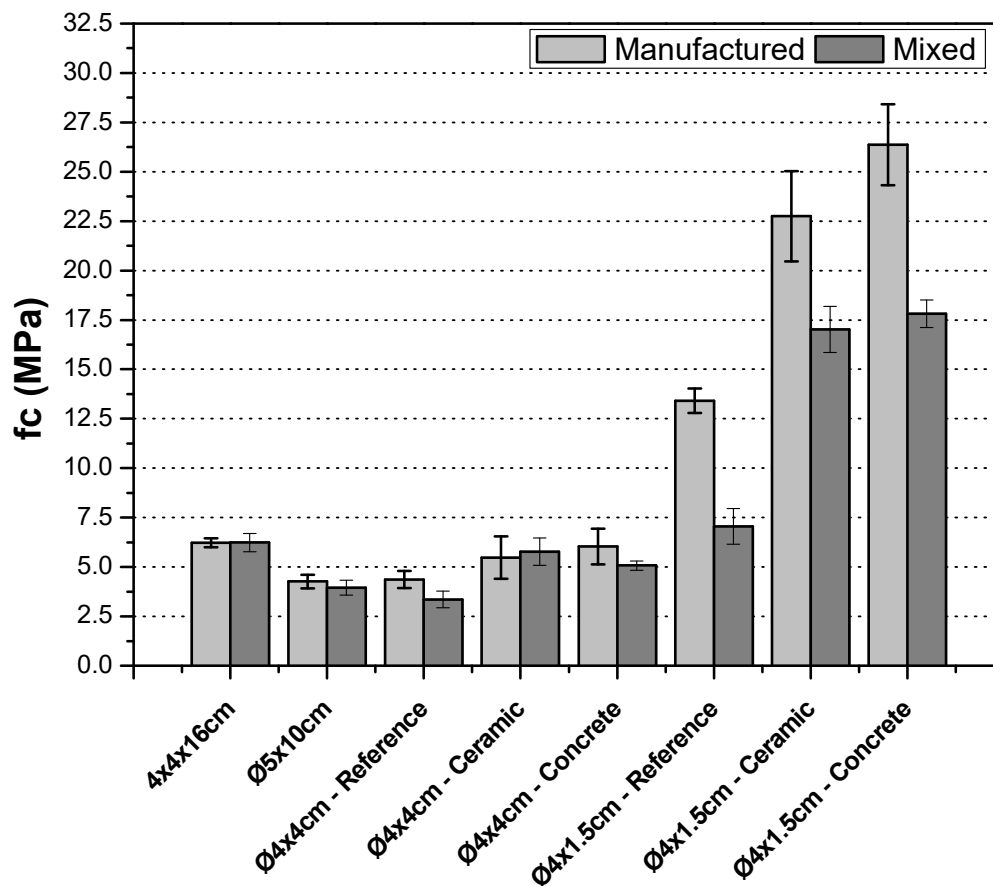
Figure 3: Strength of the studied specimens.

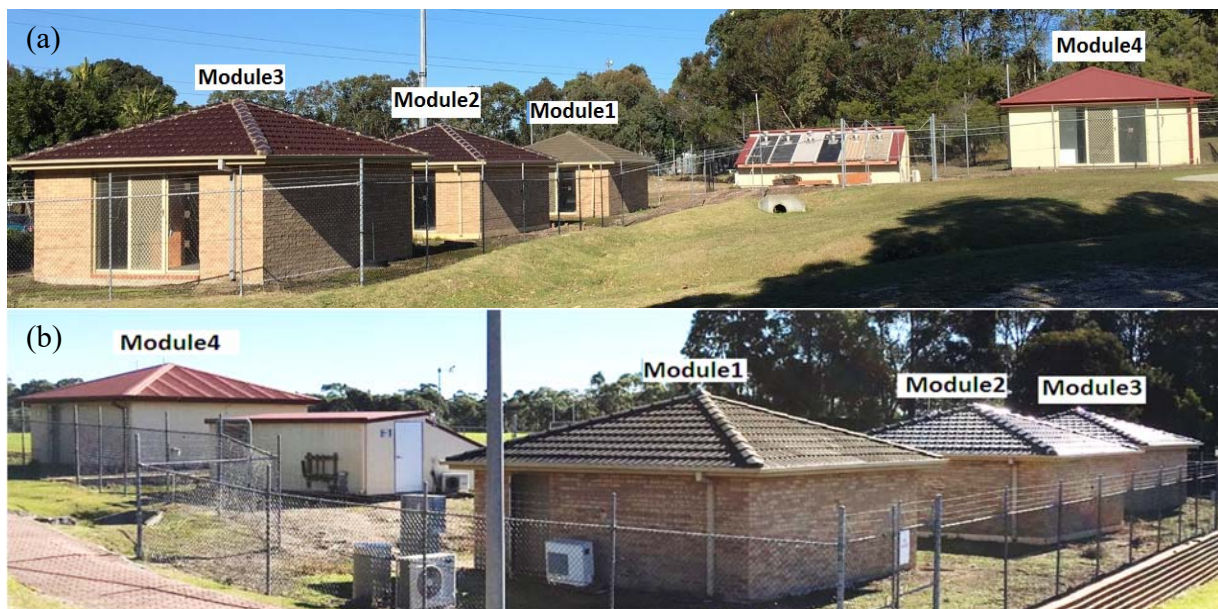
Figure 1: View of modules: (a) from Northern view and (b) from Southern view. Note: Module 1 – InsBV, Module 2 – InsCB, Module 3 – CB, Module 4 – InsRBV.

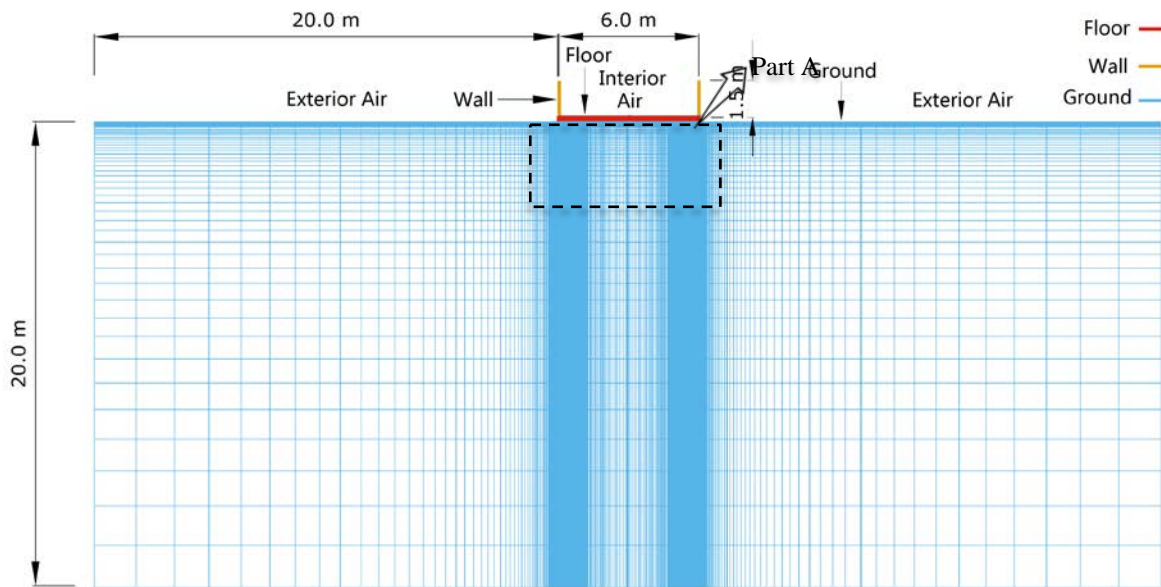
Figure 8: Grid of solution domain

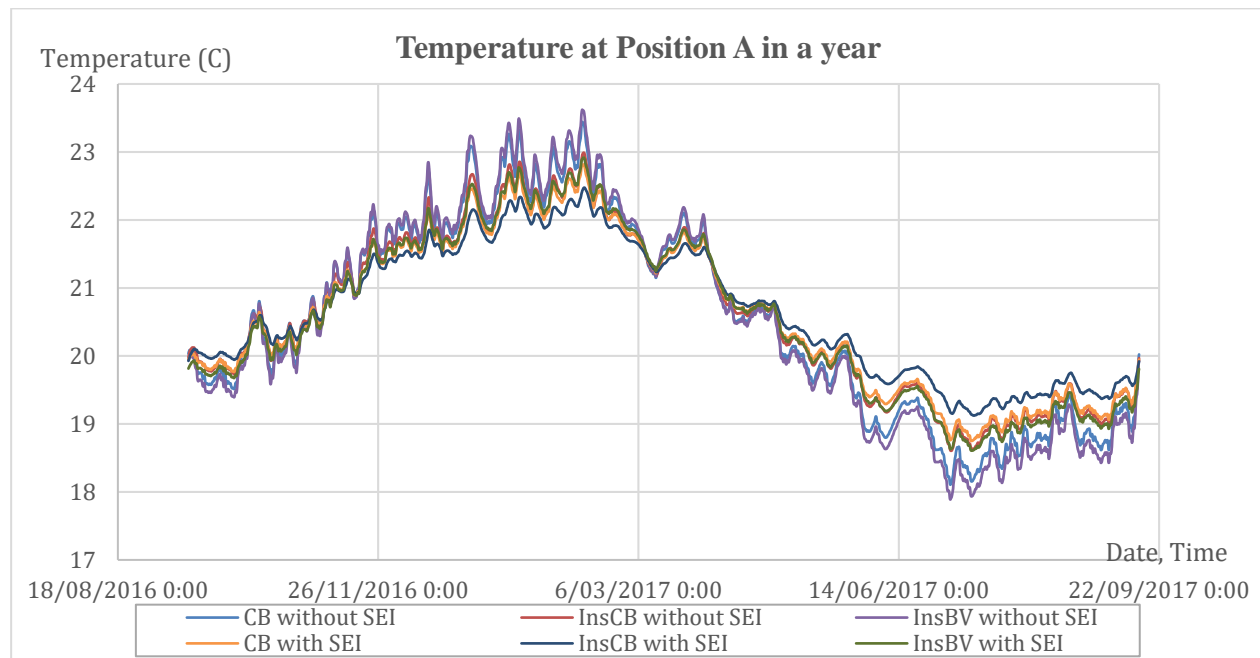
Figure 15: Yearly temperature fluctuation at Position A

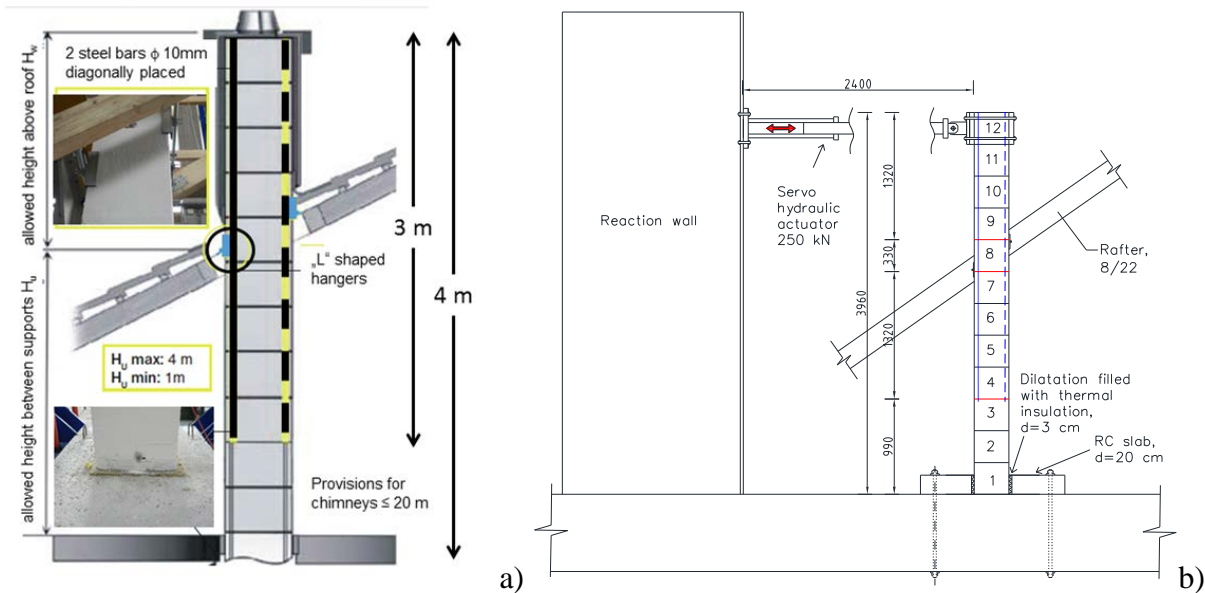
Figure 2: Reinforcement for chimney systems type A and B, lateral support system of the chimney at the roof level and detail of connection through RC slab a), test set-up for laboratory testing b).

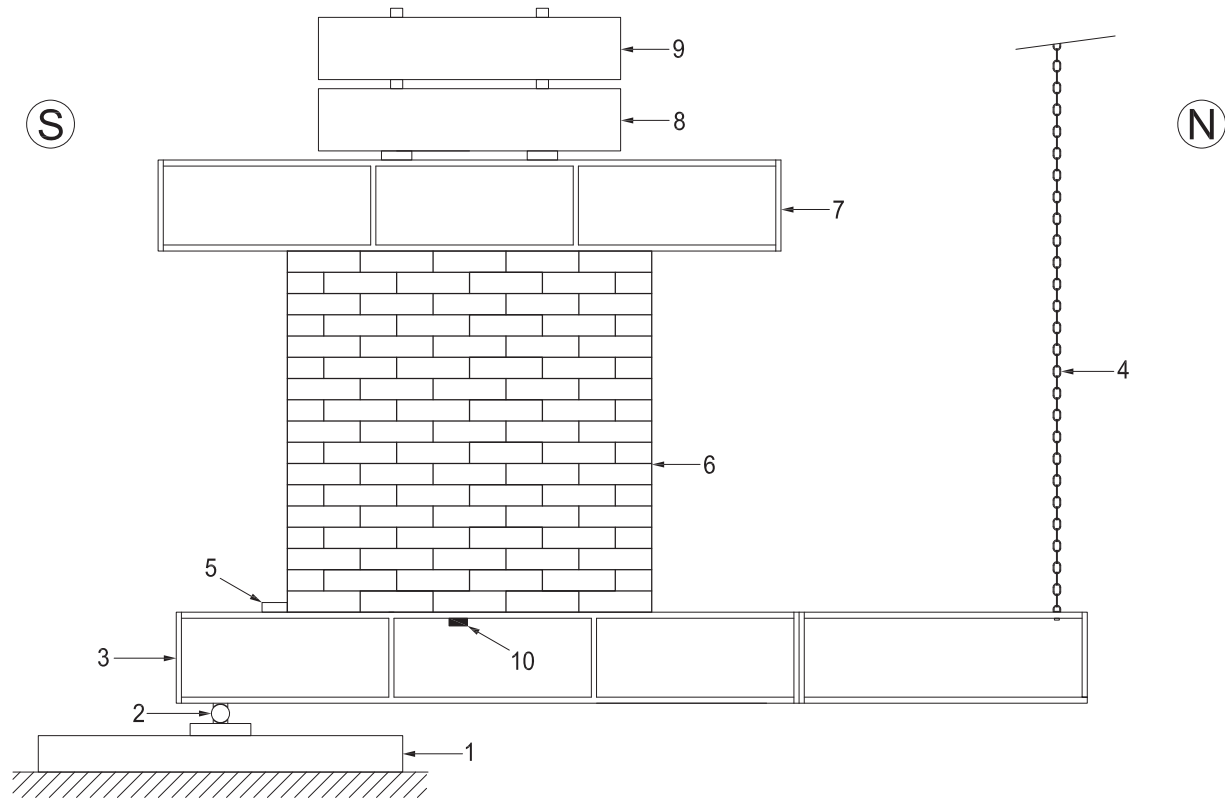
Figure 3: Test set-up

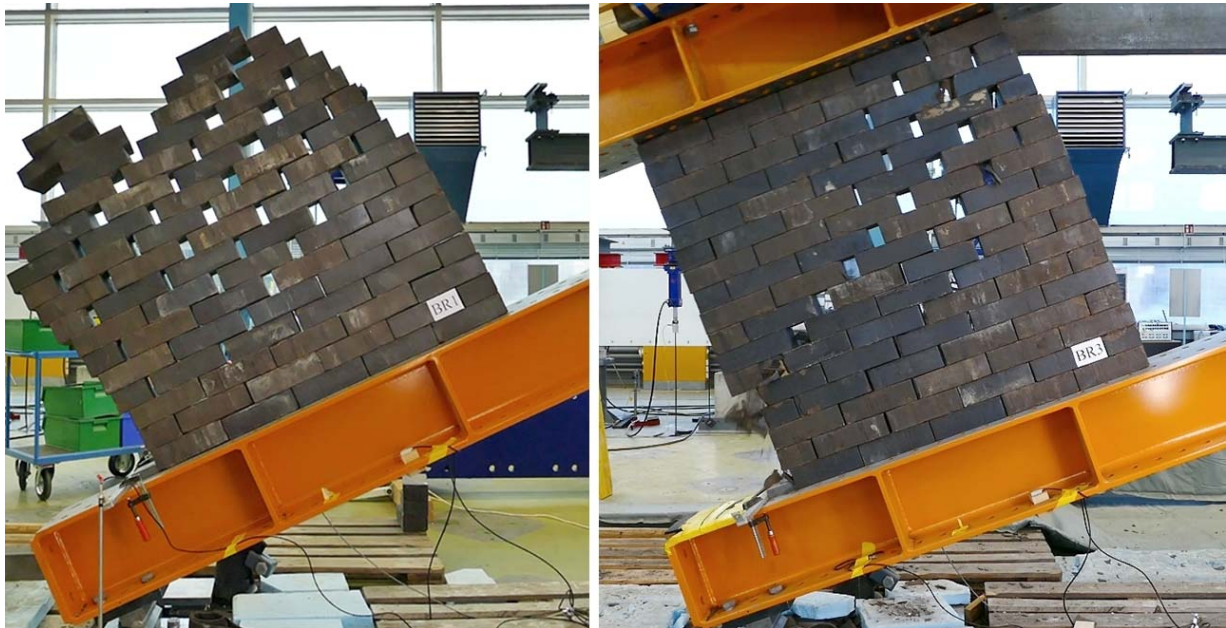
Figure 6: Shear failure of specimens BR1 and BR3

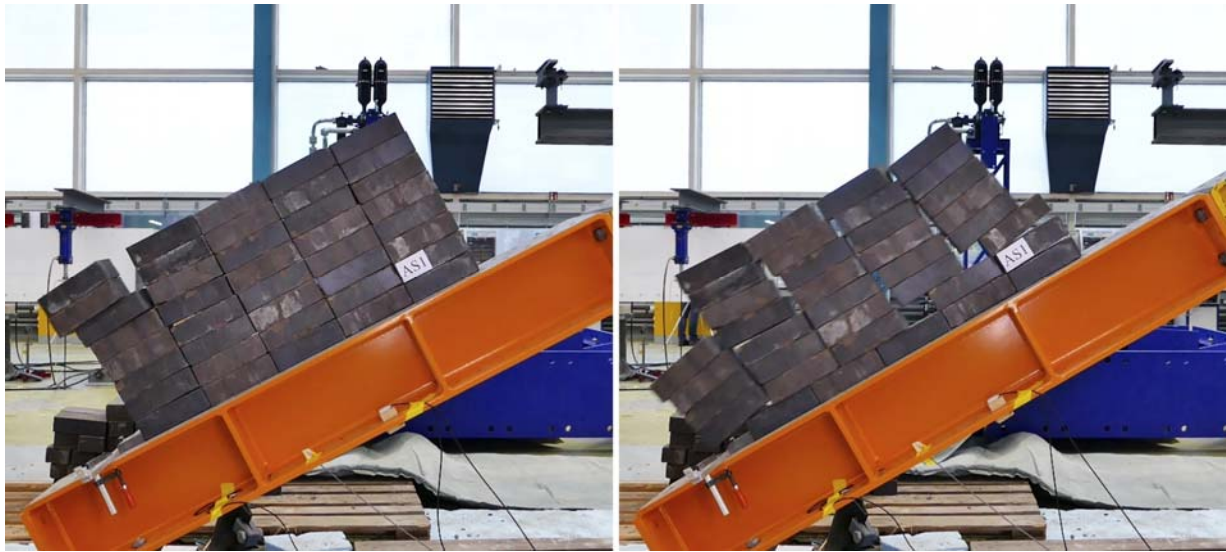
Figure 9: Development of sliding failure of specimen AS1

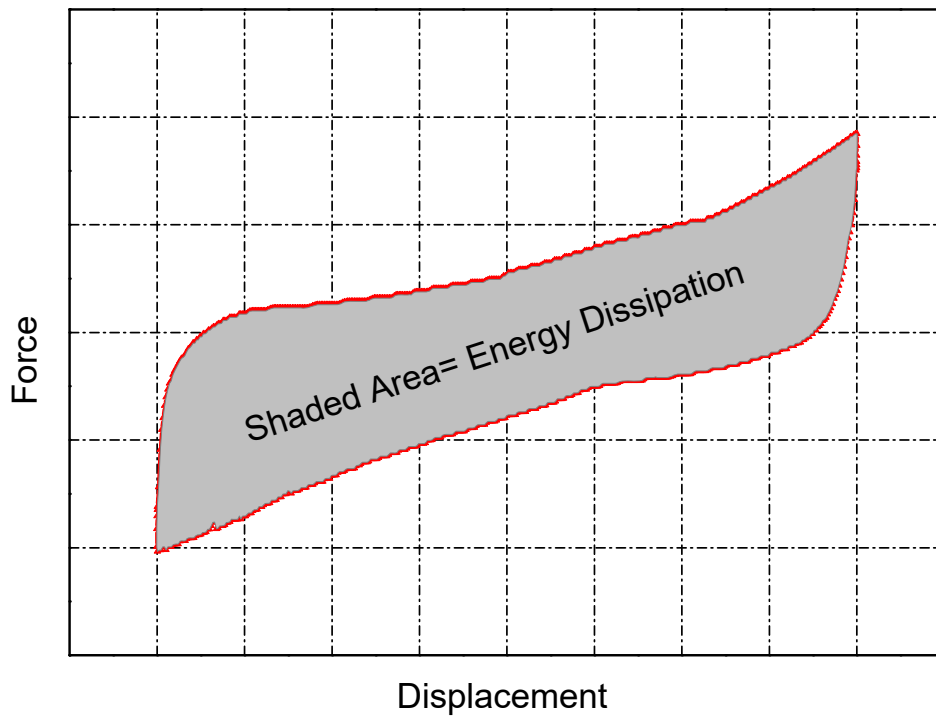
Figure 9: Energy dissipation of a cycle

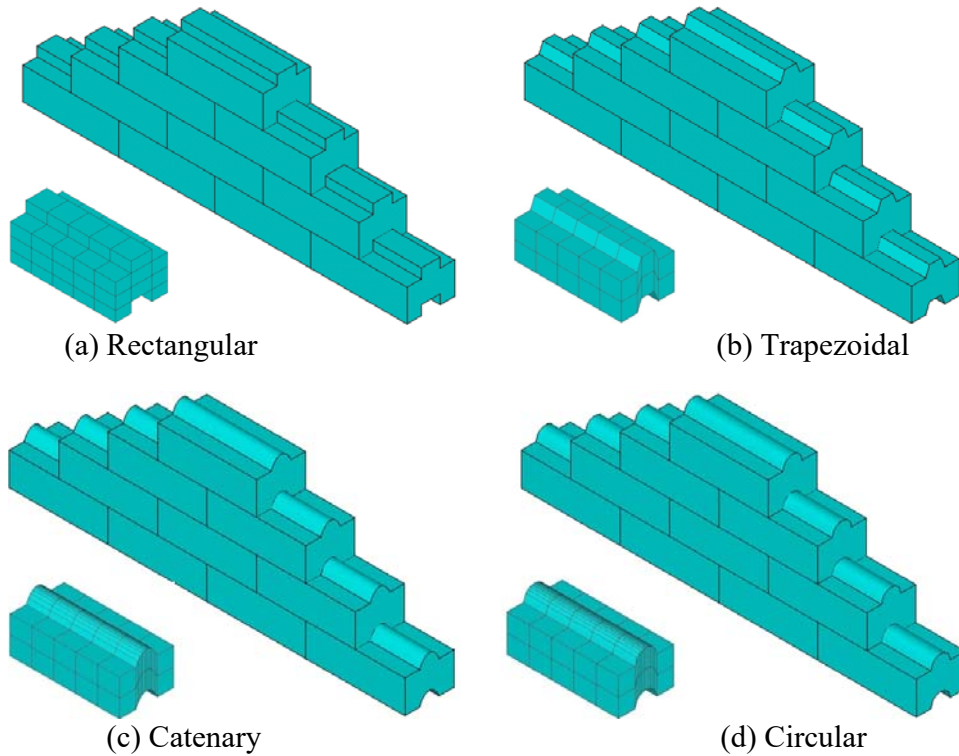
Figure 9: FE Model and meshing condition of different interlocking shape

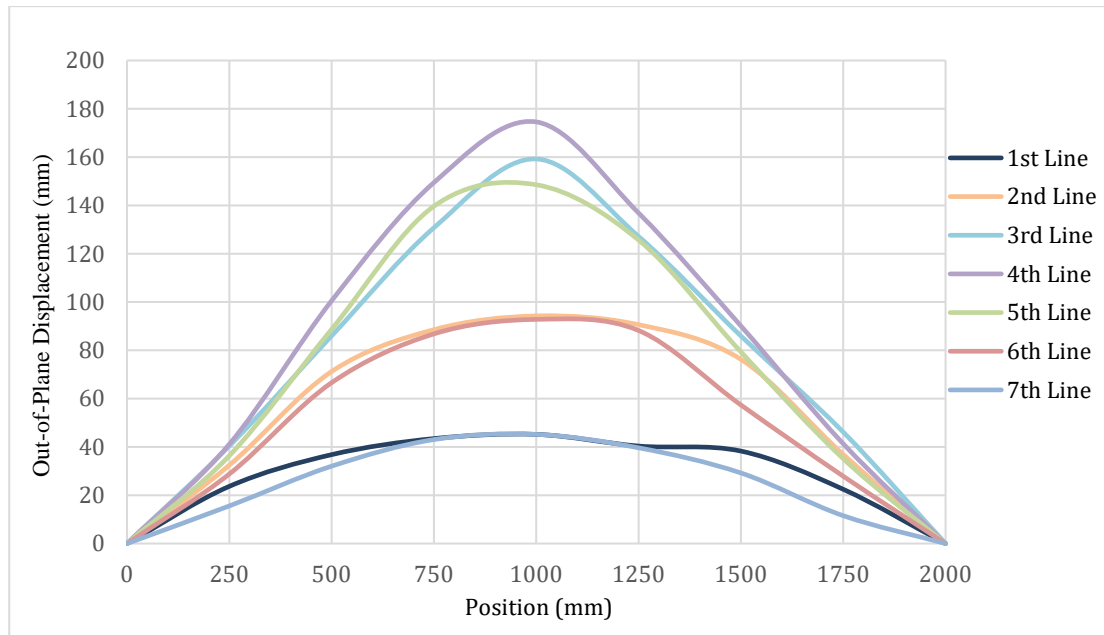
Figure 6: Displacement diagram for selected lines at an applied load of 27.8 kN

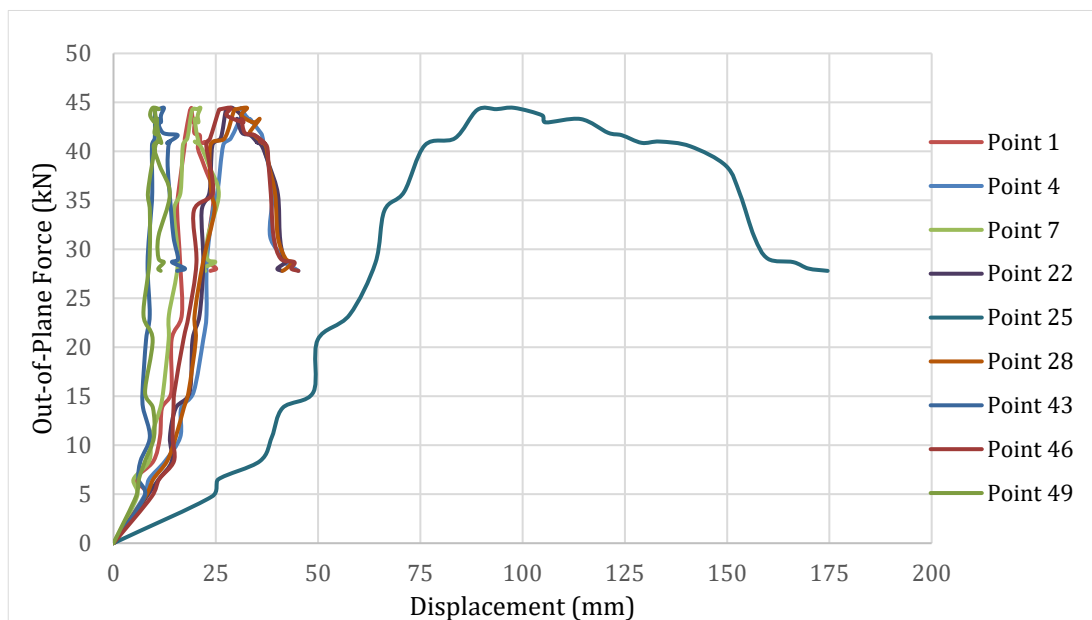
Figure 9: Force-displacement of the selected points

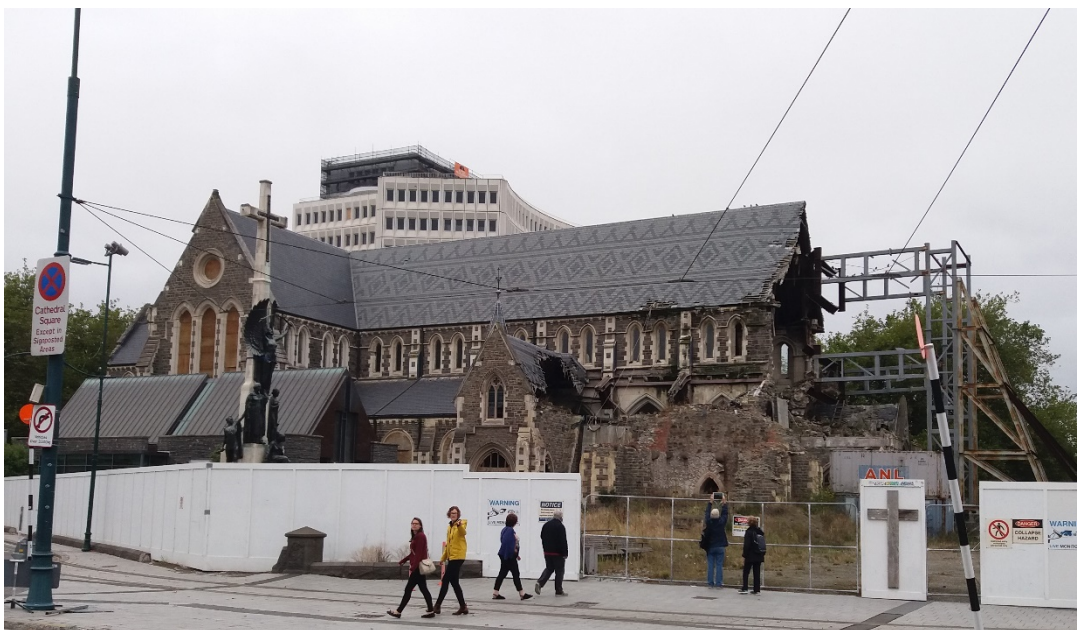
Figure 1: Post-earthquake risk mitigation of Cathedral Church of Christ (Anglican Cathedral) using temporary steel props, 2017

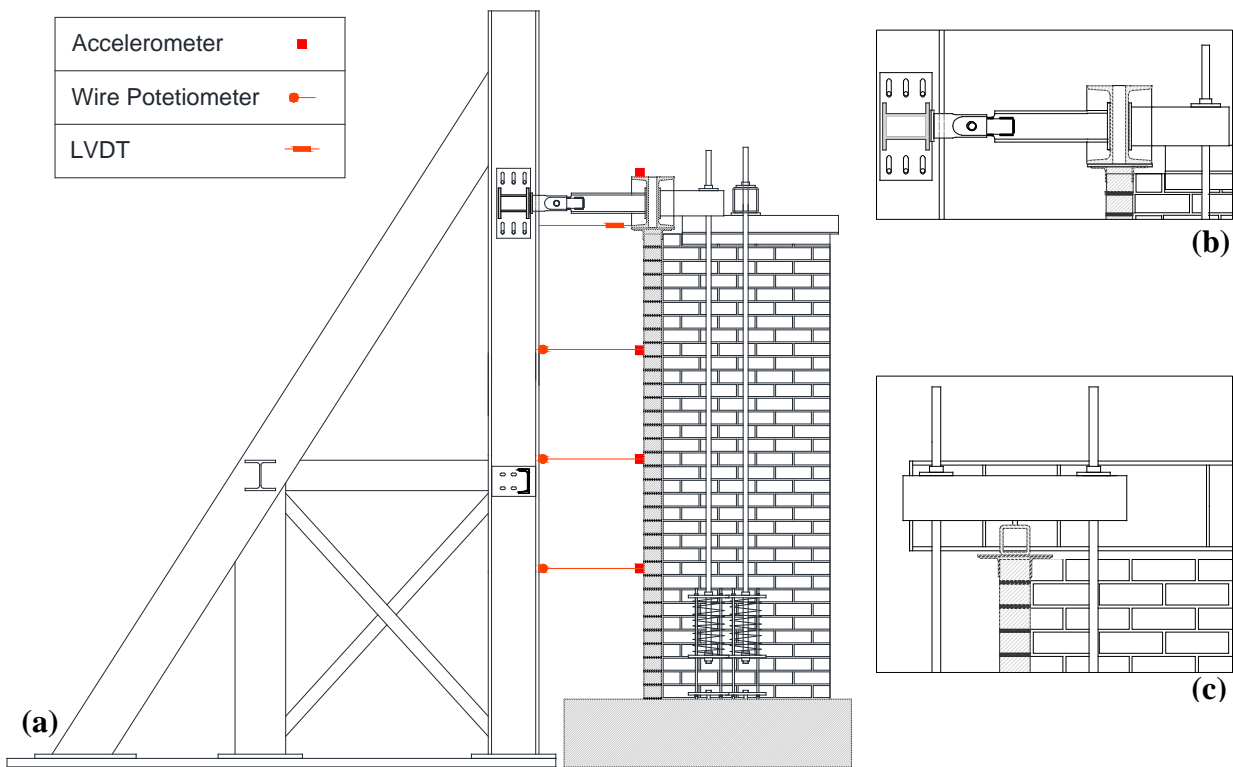
Figure 1: Geometry of the test set-up: general view (a), connection between top beam and rigid frame (b) and return wall loading system (c).

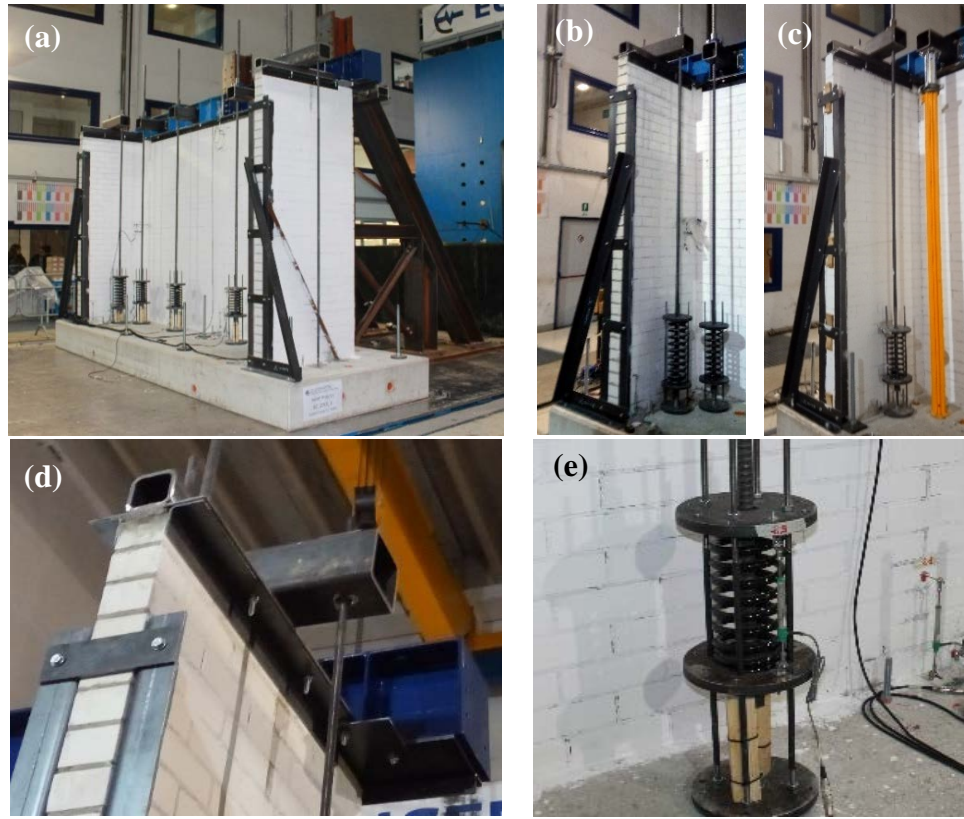
Figure 2: Testing layout: general view (a), loading systems (b, c, d) and spring system (e).

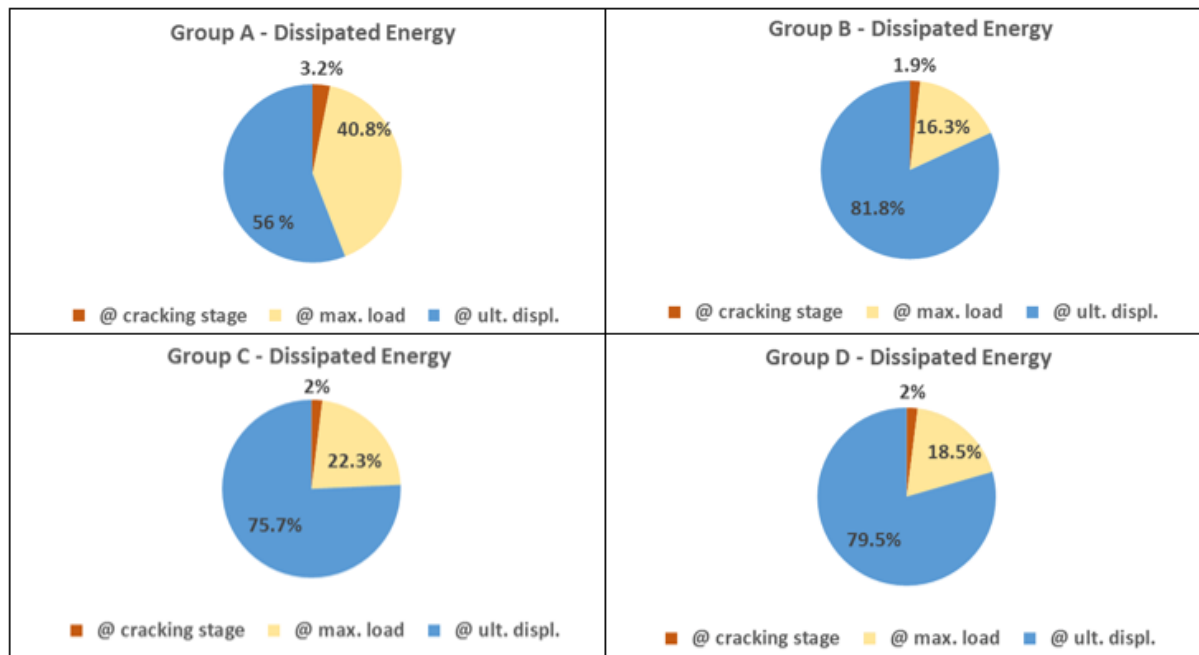
Figure 6: Dissipated energy at the three different stages for Groups A-D on a percentage basis to the total dissipated energy

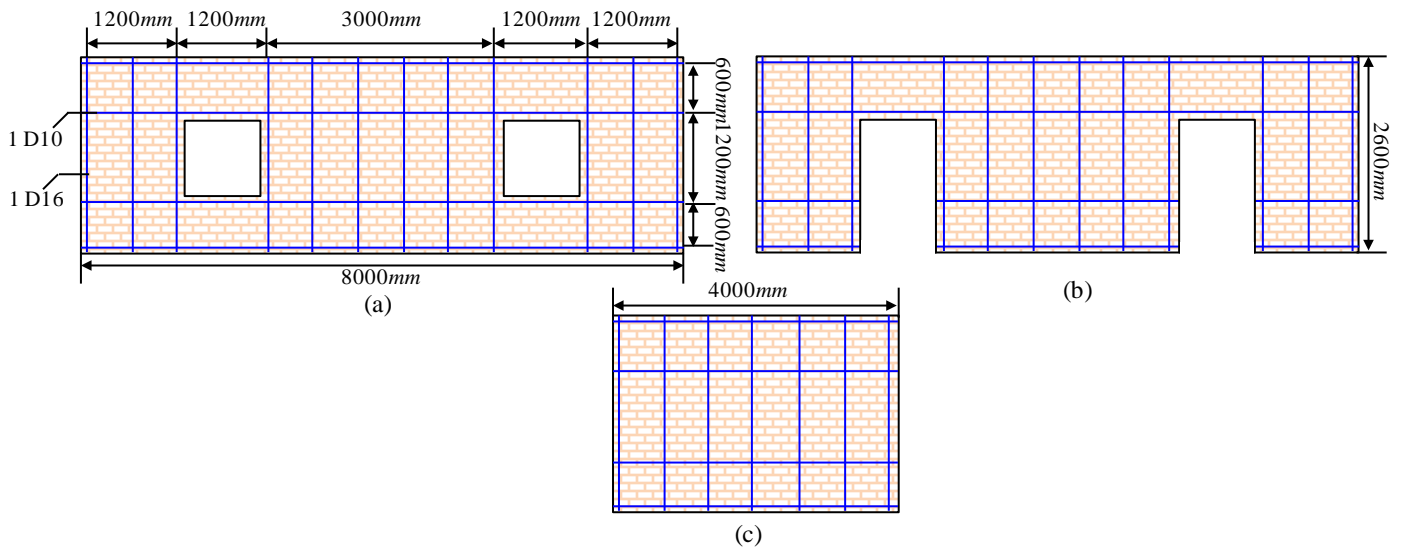
Figure 1: Structural detail; (a) Wall A; (b) Wall B; (c) Wall C

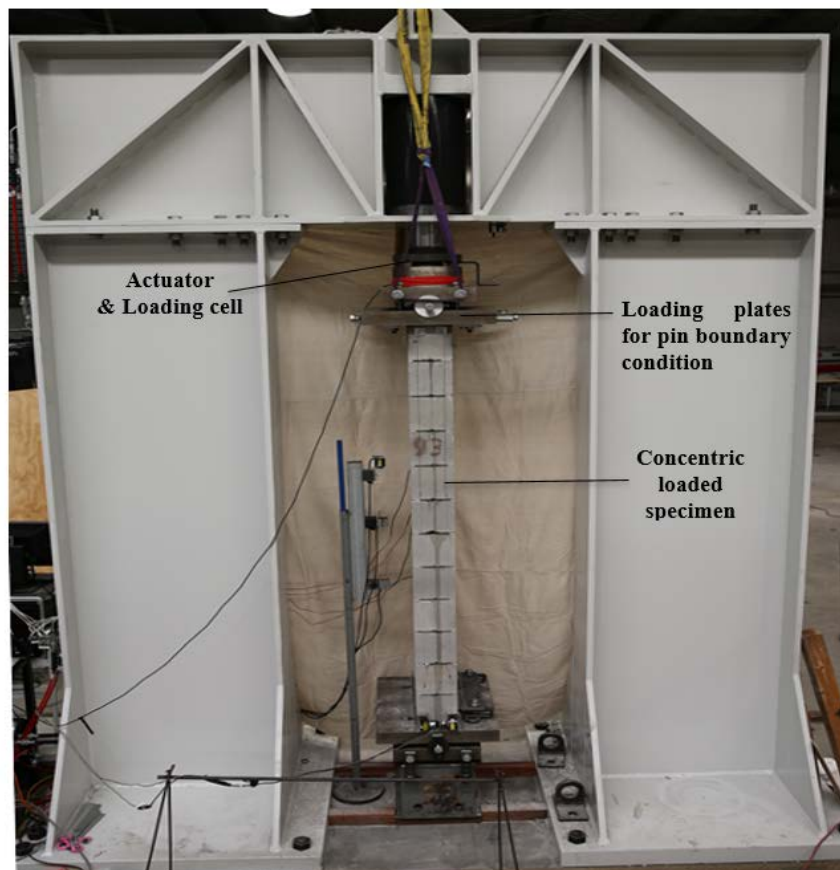
Figure 3: Testing layout for concentric loaded specimens
