PROCEEDINGS

10TH AUSTRALASIAN MASONRY CONFERENCE

Masonry Today and Tomorrow

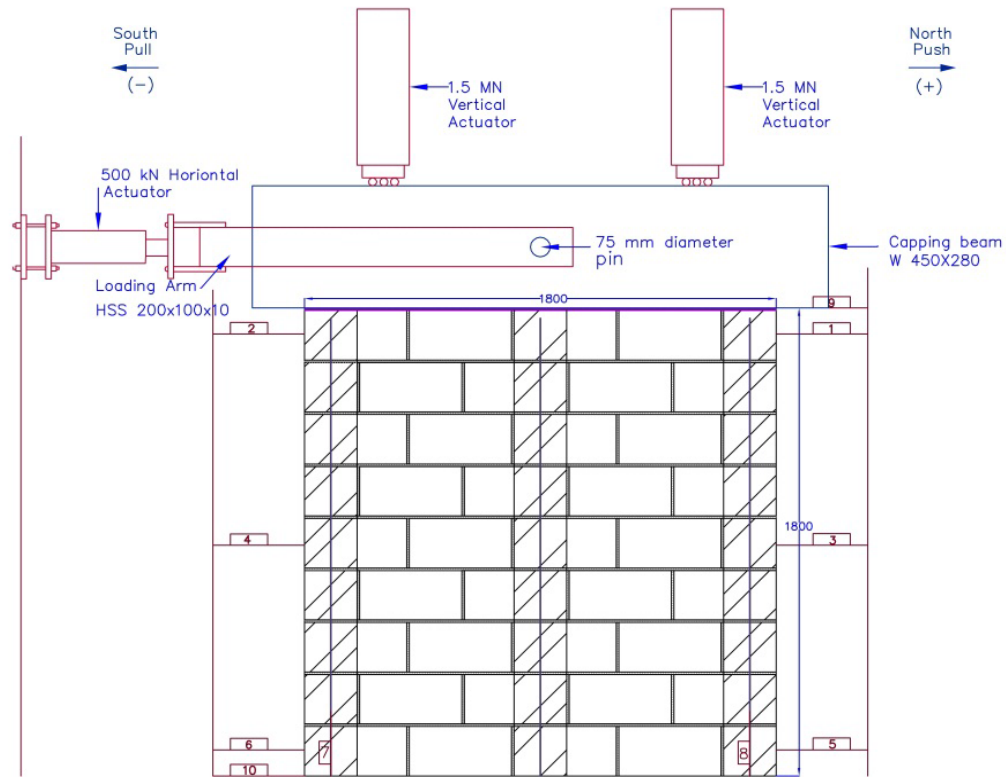
Figure 1: Typical test arrangement

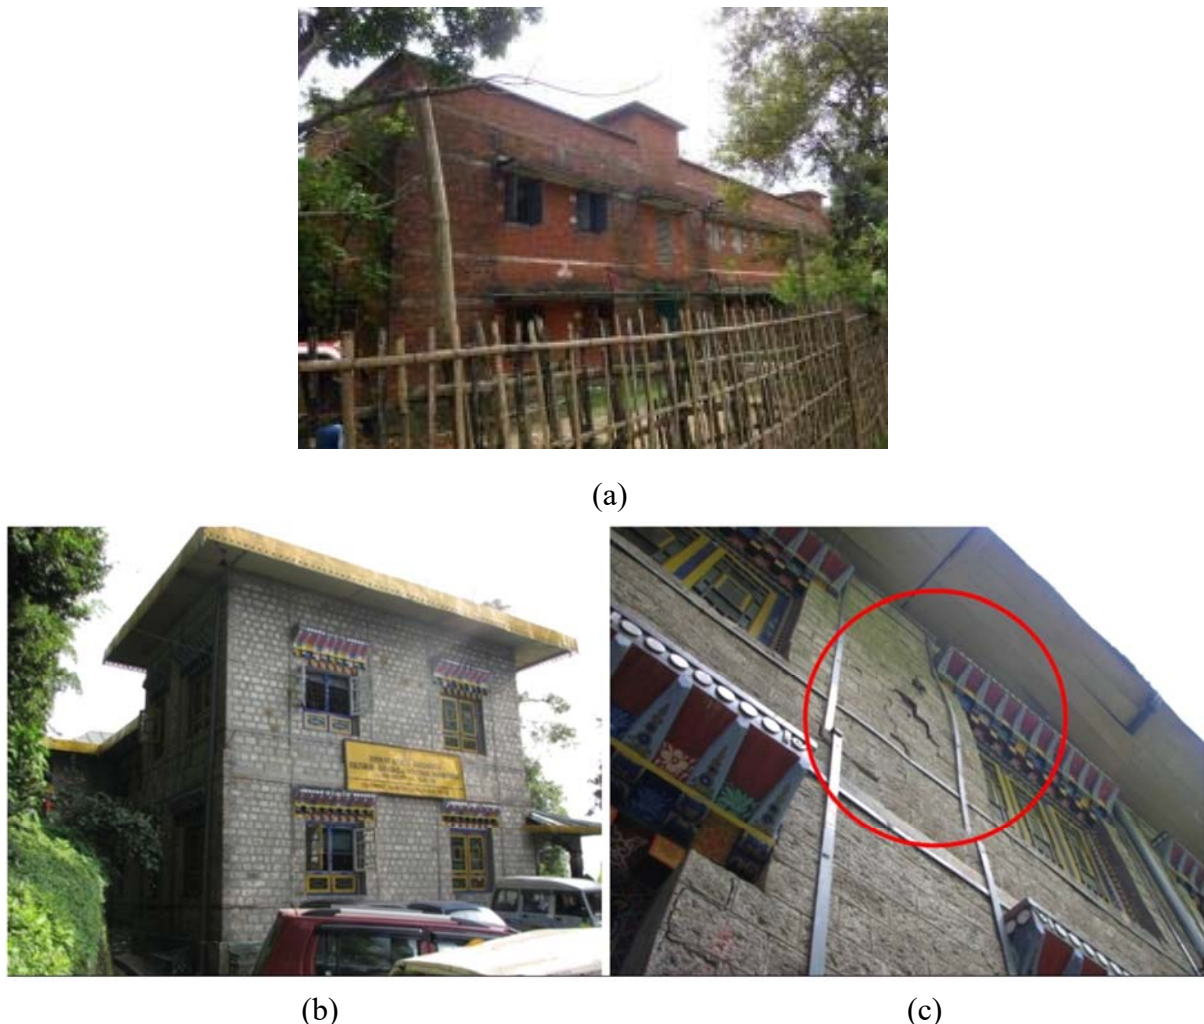
Figure 1: (a) Typical Unreinforced Brick Masonry with GI Sheet (Choudhury et. al, 2015) (b)(c) Retrofitted building using steel flats (Kaushik & Dasgupta, 2014)

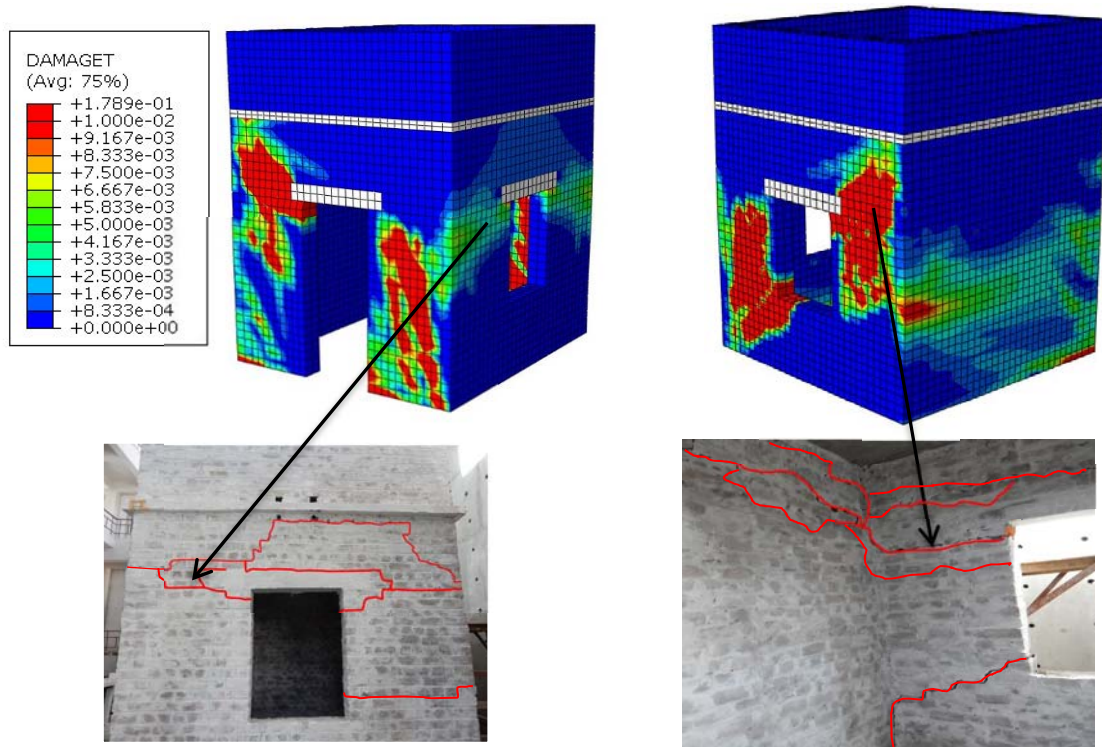
Figure 3: Damaged states of URM building

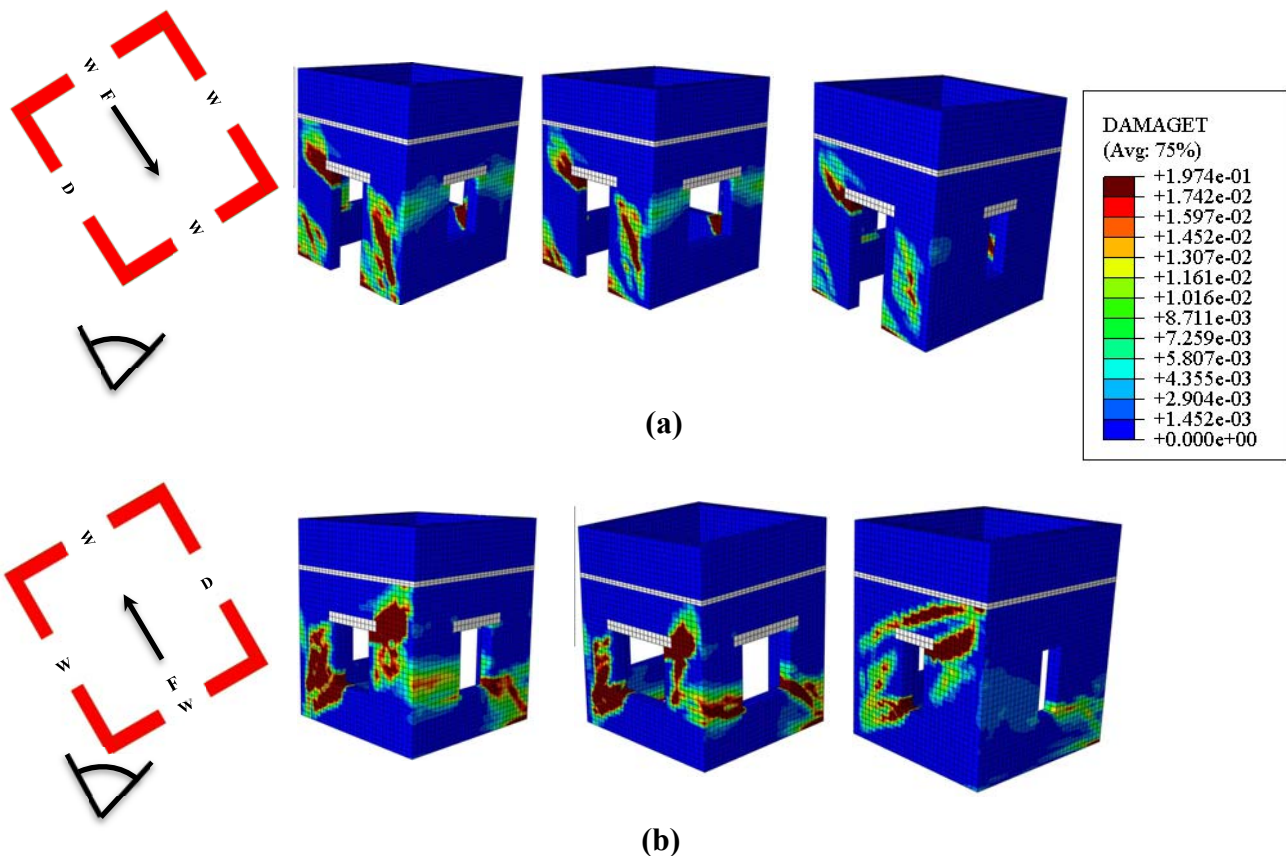
Figure 7: Damage distribution in Plan 2 with various window sizes

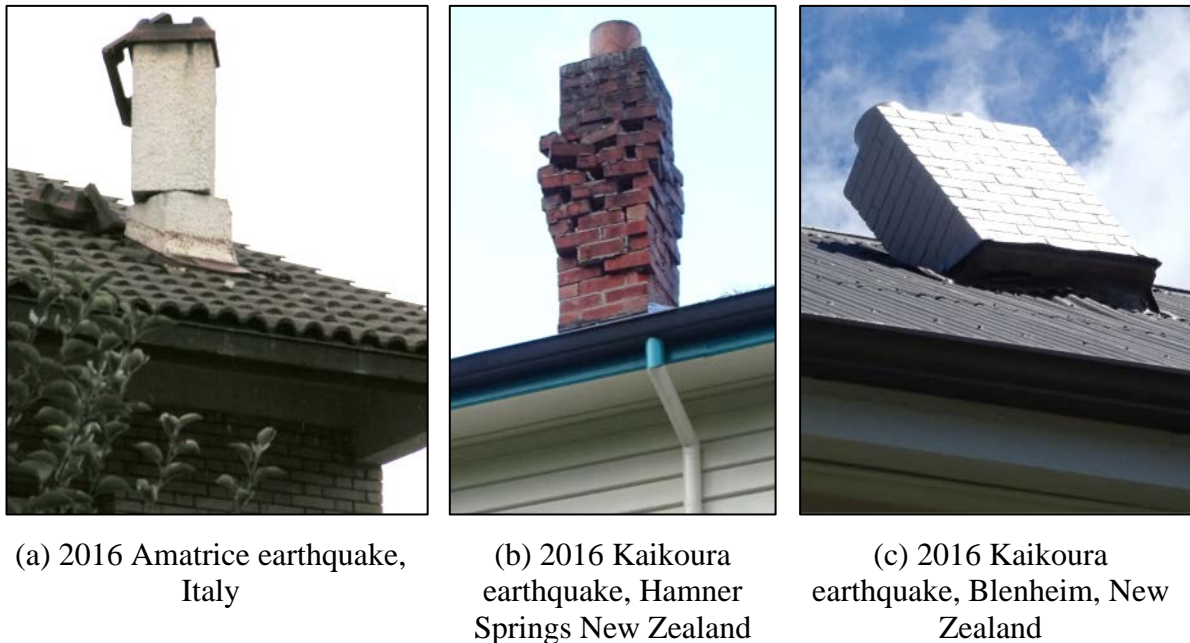
Figure 1: Examples of damaged chimneys

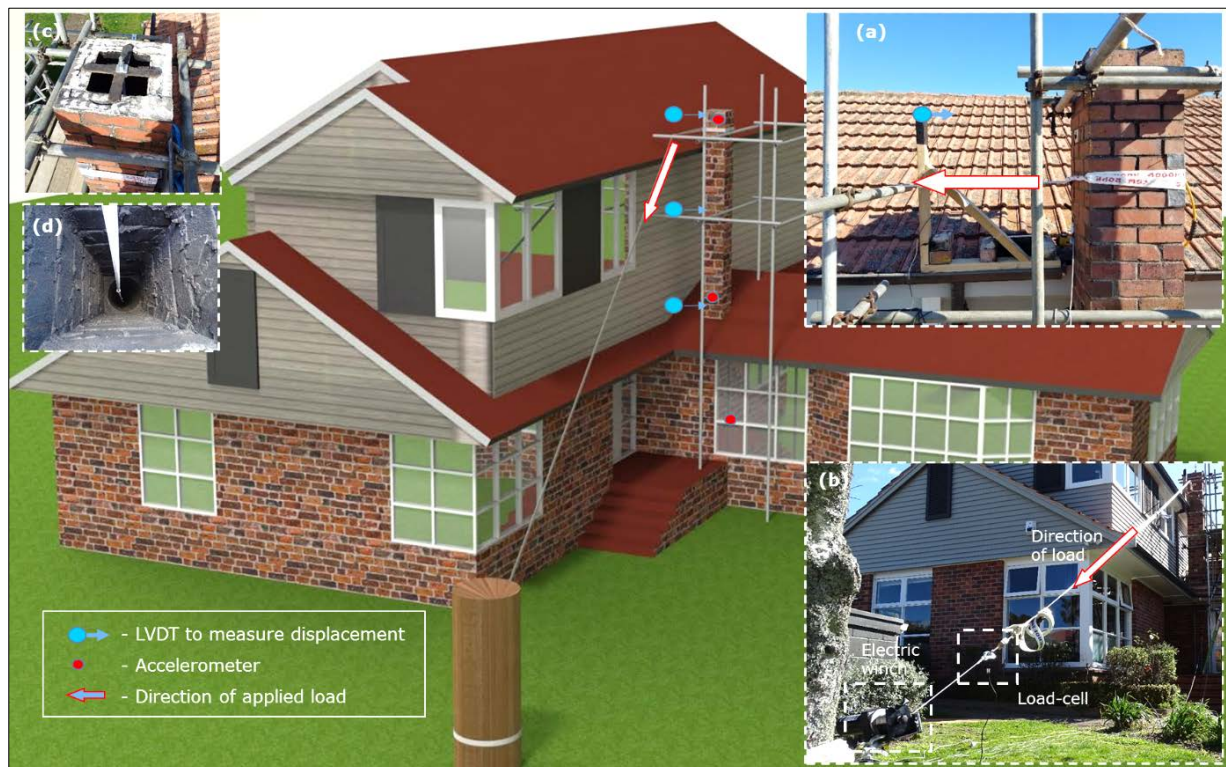
Figure 4: Schematics of loading and instrumentation-setup for chimney A1: (a) Top portion of chimney showing loading direction and location. (b) Location of load-cell and load application mechanism. (c) Top portion of chimney showing cruciform anchor plate for PT retrofit. (d) PT threaded steel rod inserted down chimney flu.

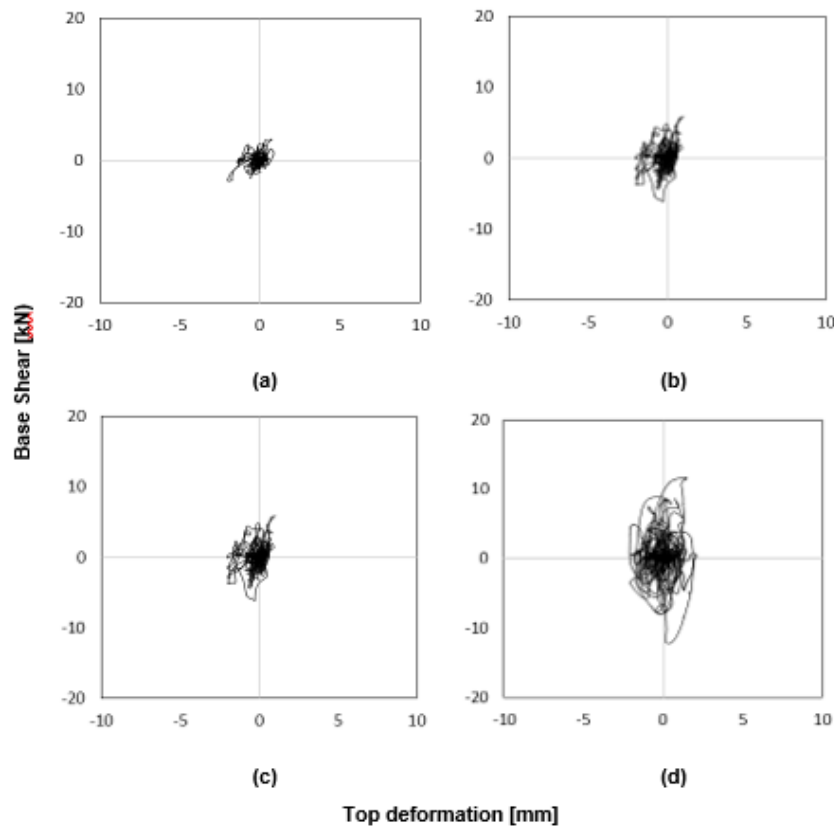
**Figure 5: Hysteresis loops for Wall A at different intensities of Signal 1:
(a) 25%, (b) 50%, (c) 75%, (d) 100%.**

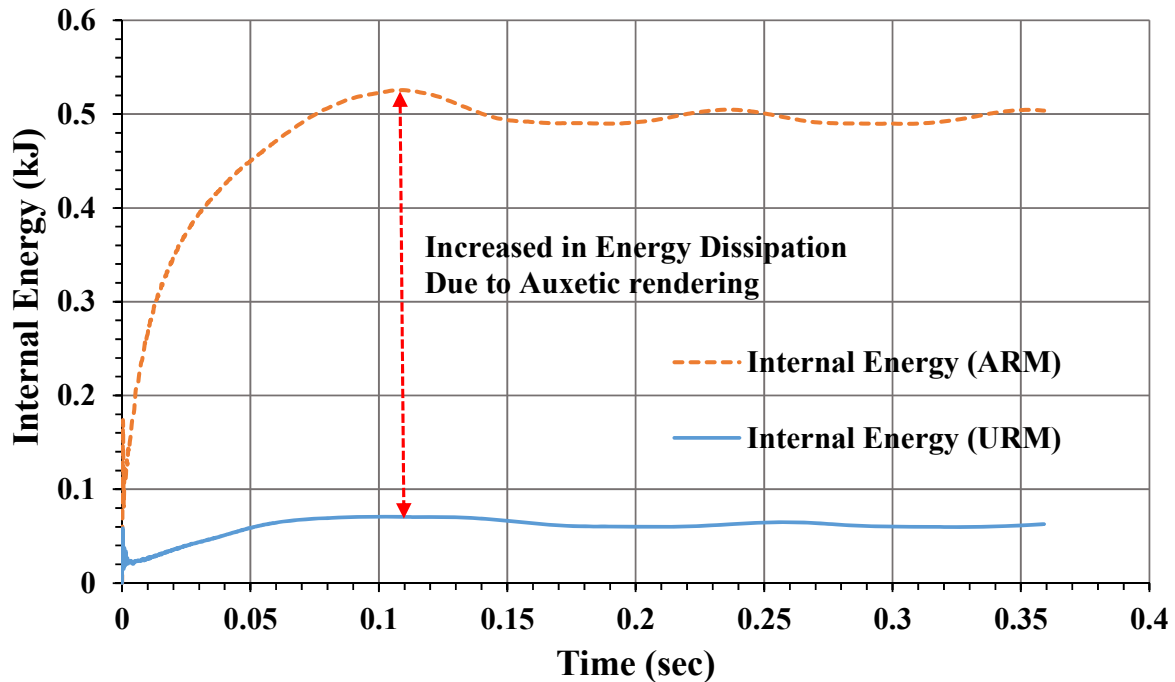
Figure 10: Internal energy versus time graph to compare the energy dissipation due Auxetic rendering on both face of Masonry wall during impact.

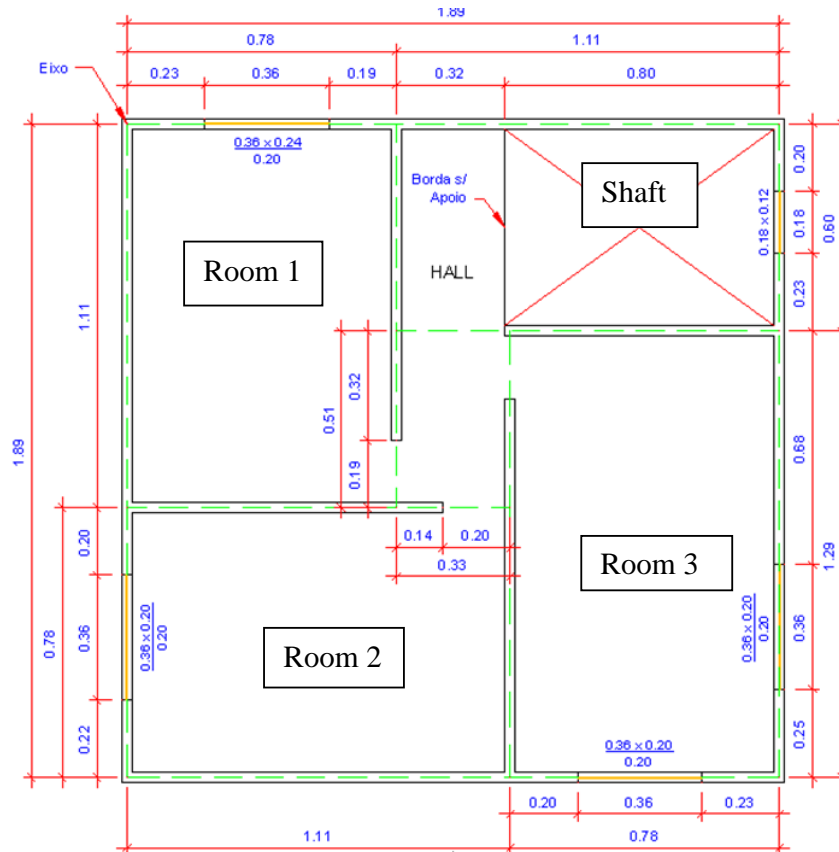
Figure 3: Typical floor of the small-scale (1:5) building – Dimensions in m.

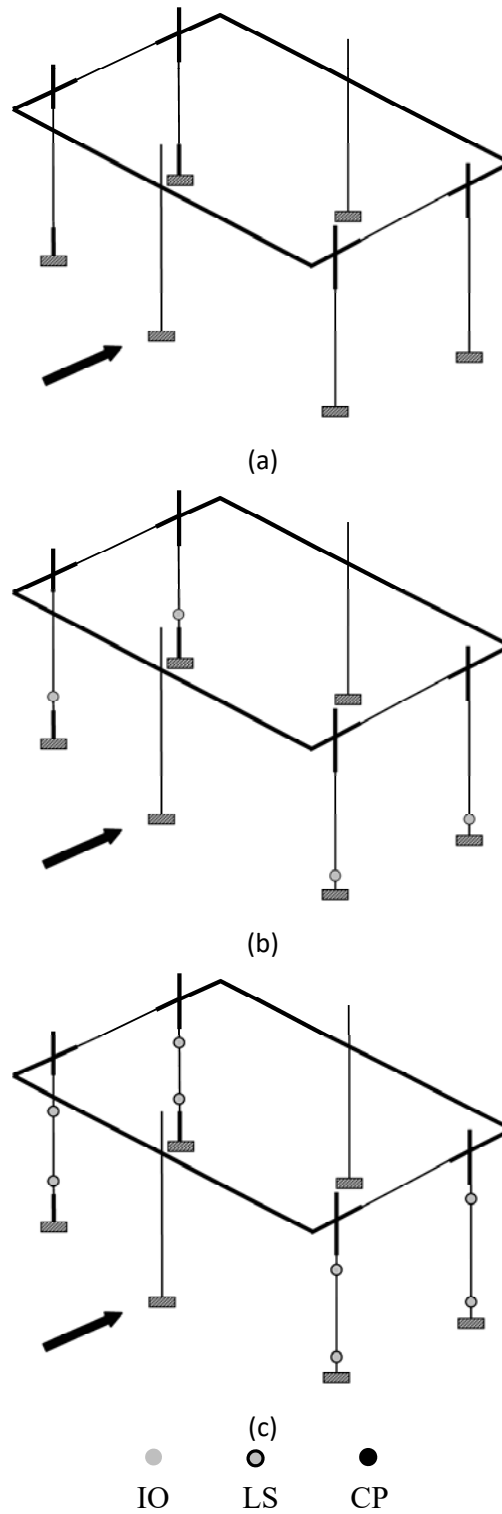
Figure 9: Plastic hinge patterns in retrofitted building model subjected to: (a) shock-3; (b) shock-4; and (c) shock-5
